Site Visit to (b) (6) Orchard

OSC, Joni Sandoval and ER, Art Slayton

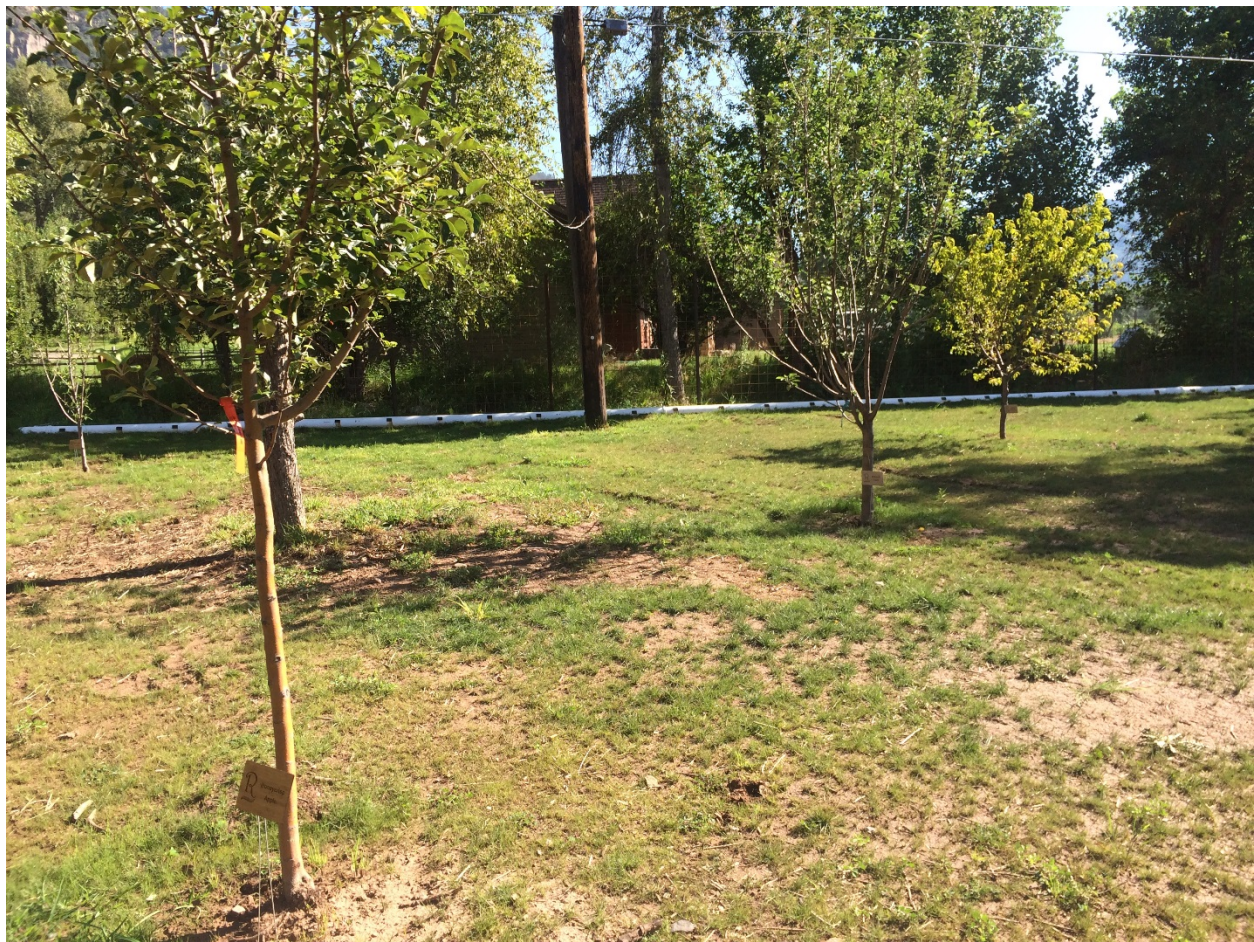
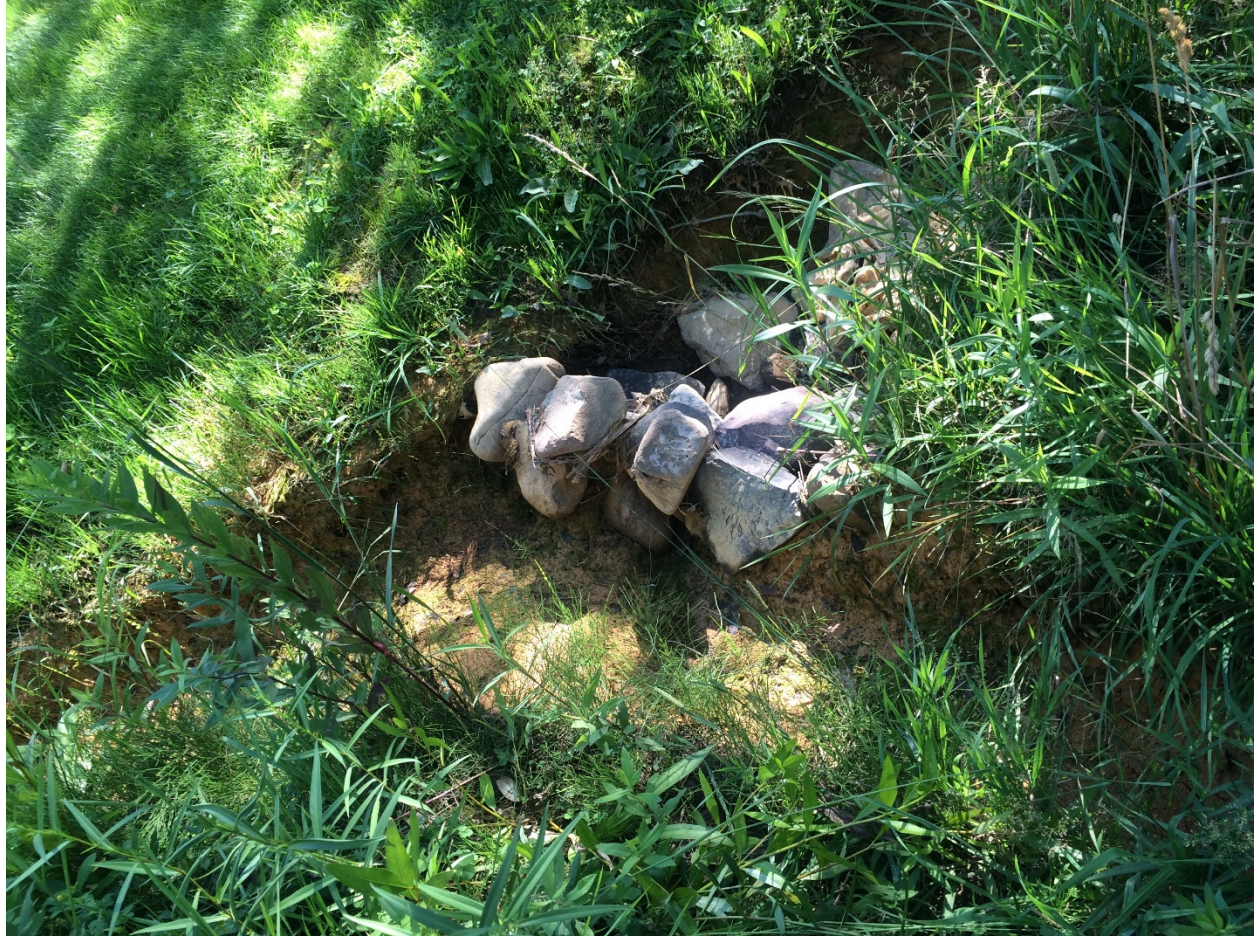
We visited the Orchard on 08/14/15 where there are approximately 25 types of trees planted. (b) (6) was concerned with the orange stained ditch (Animas Consolidated) behind the orchard that feeds into his flood type irrigation system. It is a PVC pipe that is about 30 feet long, and is the only watering source for the trees. Upon inspection, there was only a tiny amount of orange sediment found settled in the head of the PVC piping. (b) (6) had concerns regarding being able to water his trees with the water from his ditch. He has requested a recommendation from the EPA on mitigation if any is warranted as well as assurance the water is safe. OSC recommendation is to have an EPA toxicologist explain the sediment/water results with the owner and let him know we feel it's safe to open his head gate and start watering.
